Case Study #4: Floor System Analysis

Client: Heritage Homes of Jacksonville, Jacksonville, Florida

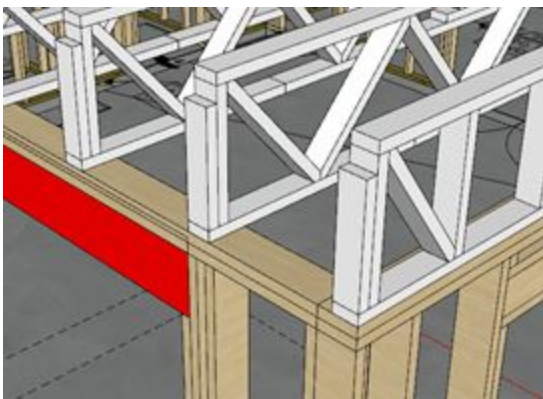
The foundation walls were modeled per the architectural drawings. The floor truss model, provided by client, was imported into the foundation model and trusses were placed on the top plate at one corner. The first discovery, in verifying alignment around the entire house, was a very common mistake/issue - when the trusses were snapped to the plate on the front of the house, they were 1" short from flushing out with the back wall framing. The truss engineer assumed that the dimensions specified in the architectural plans were "sheathing to sheathing", so $\frac{1}{2}$ " was taken off each end to allow for sheathing. This is a common practice, however the architectural plans dimensions referenced "framing to framing". Every builder has probably dealt with this sort of issue (too short or too long) at some point in time, and has had to spend time and money correcting them in the field. We prevented that from occurring.

Trusses were placed flush with framing on front wall

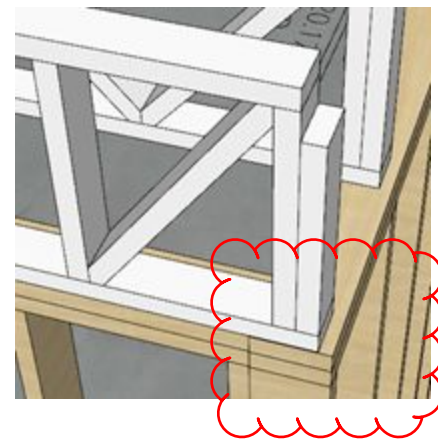
Trusses were 1" short on rear plate

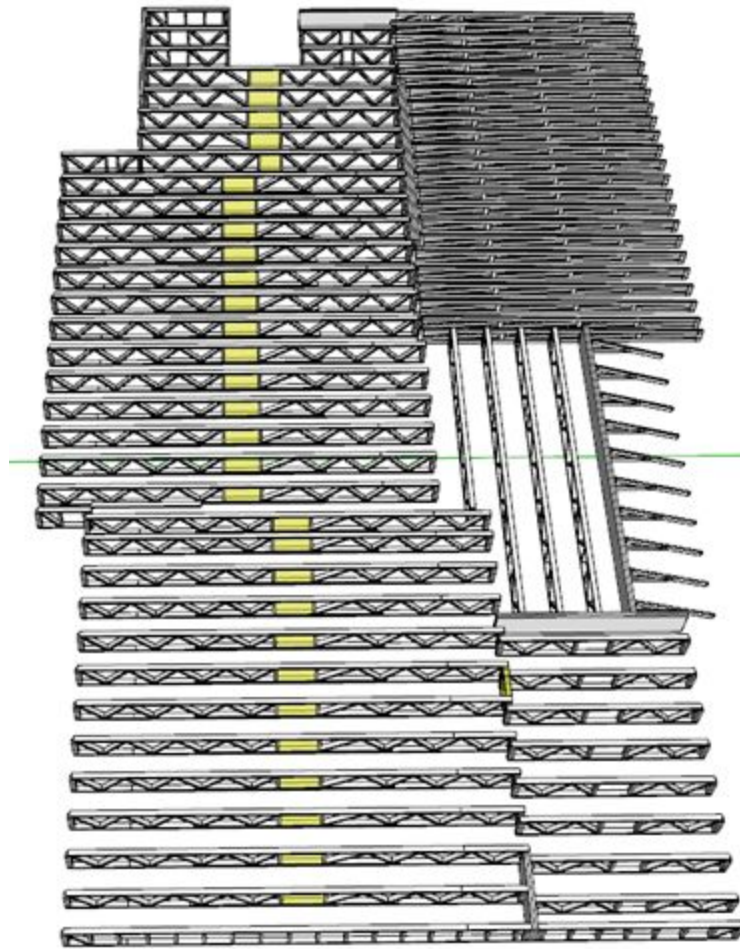
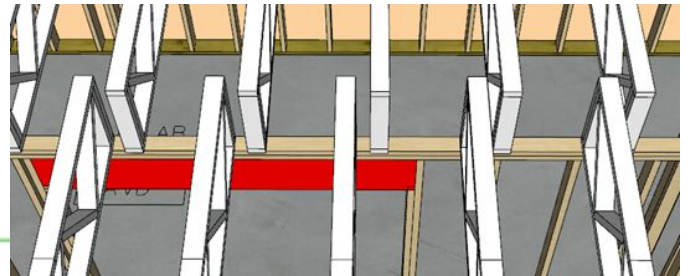
The next discovery, obvious when looking at a 3D representation of the trusses, vs a 2D drawing, was that the HVAC duct chases were not aligned. Floor trusses commonly have rectangular chases in the center portion of the truss. Many times, when a house has a bump out or recess, the trusses are engineered by default to center the chase - this situation impacts the HVAC ductwork placement.

Notice below how the chases are not aligned. There was another issue discovered as well. The garage includes a partition wall (bearing wall) between the garage and the storage and mechanical room at the rear of the garage. The HVAC system was intended to be placed in this room and the

supply duct was to go up, over the wall and into the duct chase. The truss engineer had laid out the floor trusses with staggered trusses from partition to rear wall. This would have essentially eliminated a path for the ductwork. When

the builder showed the HVAC contractor these images, he basically was told that the house was “not ductable as is”.
