Common Issues #2: Stair Issues

Example: Stair geometry and headroom issues

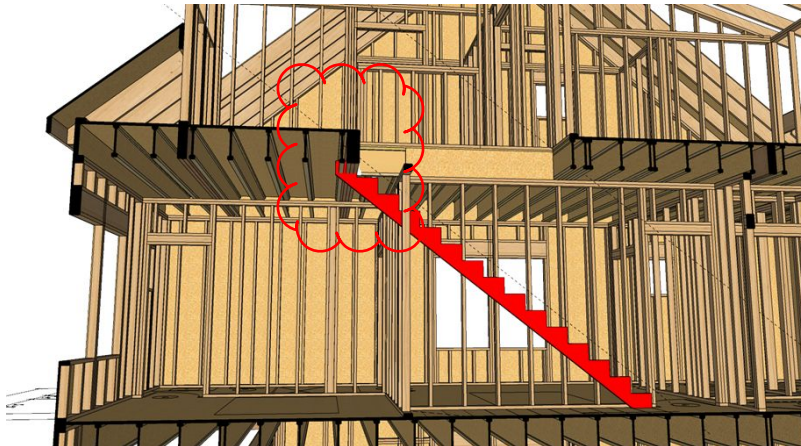
- A. Do not fit in the provided space between double beam at the top and bedroom doorway at the bottom. The maximum rise by code in this locality is $7\text{-}\frac{3}{4}$ ". With the overall rise of $10\text{' }3\text{-}\frac{7}{8}$ ", 16 risers = 7.74 " or right at the maximum. You can see how the beam needs to be one run over to accommodate but that beam is under roof loads above. This would go back to engineering to approve moving the beam, which impacts the hall/top of stairs

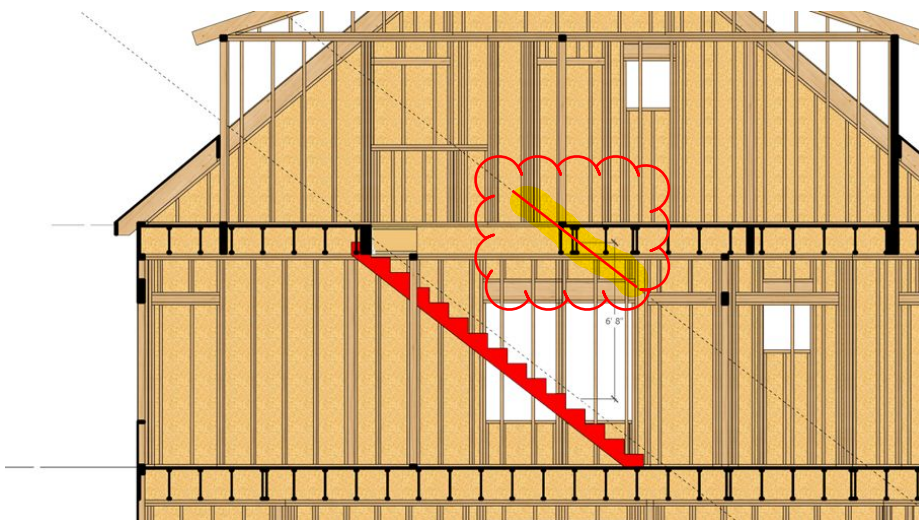
- B. There is clearly insufficient headroom. The dashed line in the image represents $6\text{'-}8$ " headroom. Had the TJIs been installed per the engineer's layout and THEN built the stairs, they would have been in for a huge headache, expense and work stoppage!
