## Case Study #7: Roof Analysis

Client: Timberidge Custom Home, Heber City, Utah

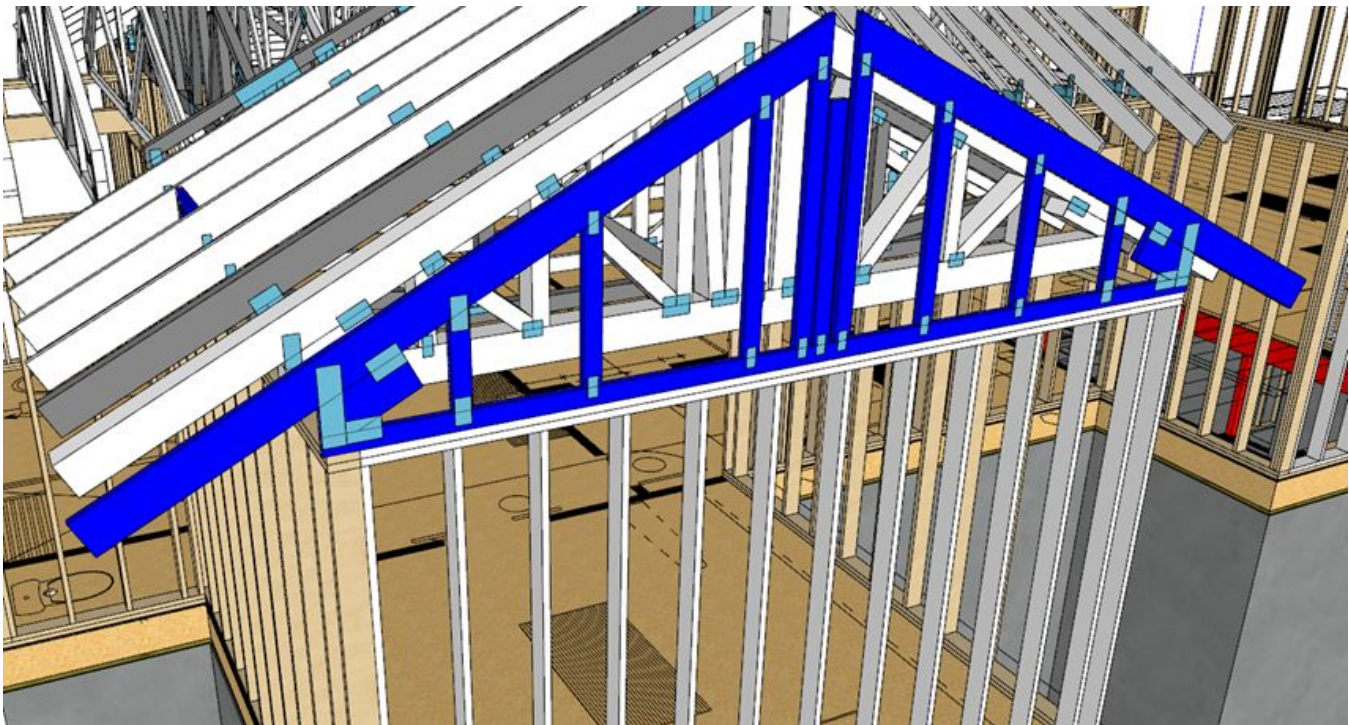
In the picture below, it is hard to see but each end of the truss sticks past the wall  $\frac{1}{2}$ ” on each end. In this case, the soffits slope (sometimes this can be concealed in the soffit for top-chord overhang trusses), BUT the sheathing on this wall must continue up past the top of the wall. What do you do if this is not caught? Rip the truss ends? Add blocking in between to flush sheathing? Either way, an avoidable issue when caught in advance!

**Issue:** As shown in an earlier case study, a common occurrence or finding across the country is that exterior dimensions are either taken as “Framing to Framing” OR “Sheathing to Sheathing”. SO, often times, we find trusses are either  $\frac{1}{2}$ ” too short on each end OR  $\frac{1}{2}$ ” too long on each end. If trusses are field-measured prior, this may not be an issue, but when it becomes an issue, framers must deal with these situations as they arise - this is costing someone money!
