Case Study #8: Roof Analysis

Client: Timberidge Custom Home, Heber City, Utah

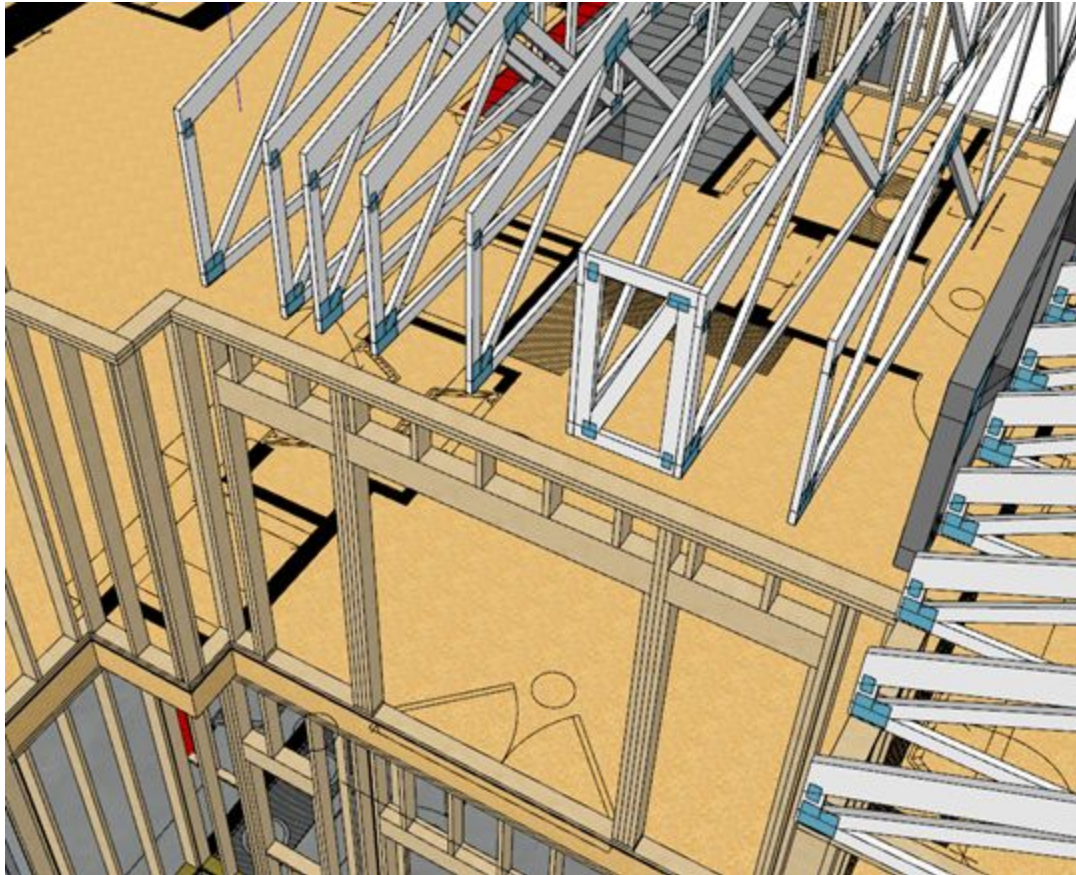
Issue: It happens, sometimes people make mistakes in dimensioning or go off of old plans or things change, but in this example, the trusses over the Study in this house do NOT sit on the wall. Granted, field-measurement, if done, may have prevented this, but so does modeling it in advance and pointing this out to the truss company to correct in advance.
