## Case Study #9: Roof Analysis

Client: Timberidge Custom Home, Heber City, Utah

**Issue:** Some bearing issues became evident when this roof was modeled.

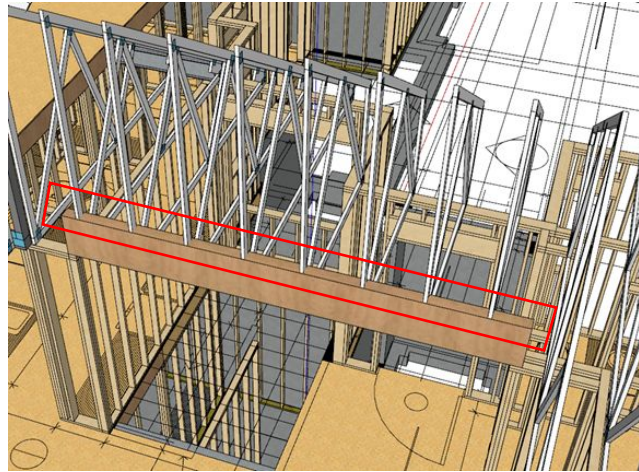
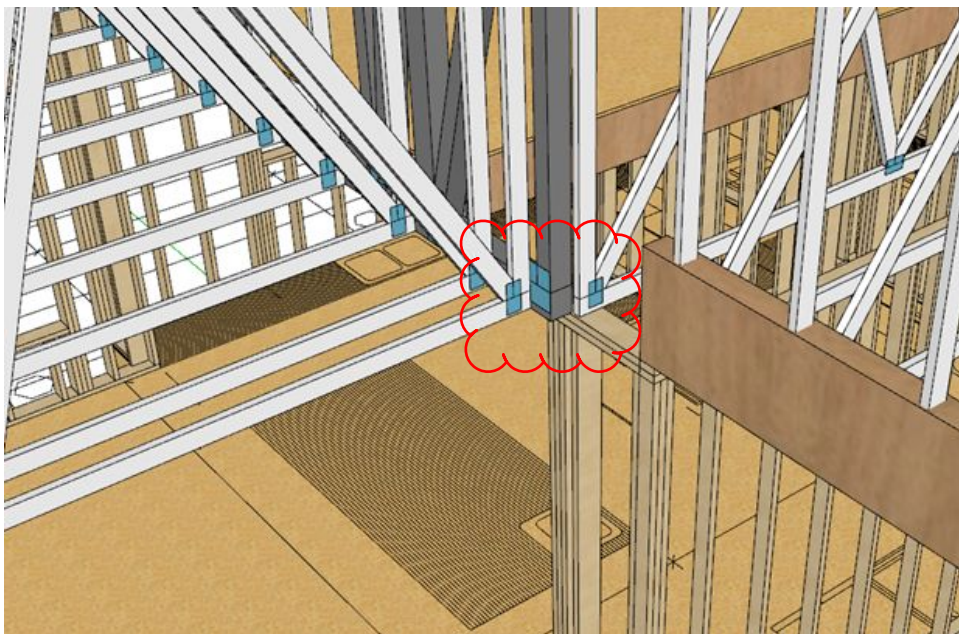
- A. The beam separating the great room from the foyer is specified to be 21" tall. The beam is intended to be flush so as not to drop ceiling. The mono trusses on top of the beam were designed to sit ON a wall or beam, NOT notched or hung from a flush beam. Easy to fix before they are built!
- B. There is a girder truss over the kitchen/dining room. The girder truss is to sit on a wall beside a run of kitchen cabinets. There is a beam underneath this point load to carry it down to the foundation below. The problem, as depicted in the image, is that the girder truss is not on the wall, it is on the "other side of the line" of the 2x4 wall! What do you do, move the kitchen wall? No, you would alter the cabinet design AND introduce a new point load that is not over top of the bearing below it.
