Common Issues #1: Structural Clashes

Example: Toilet drains directly on top of floor truss or joist

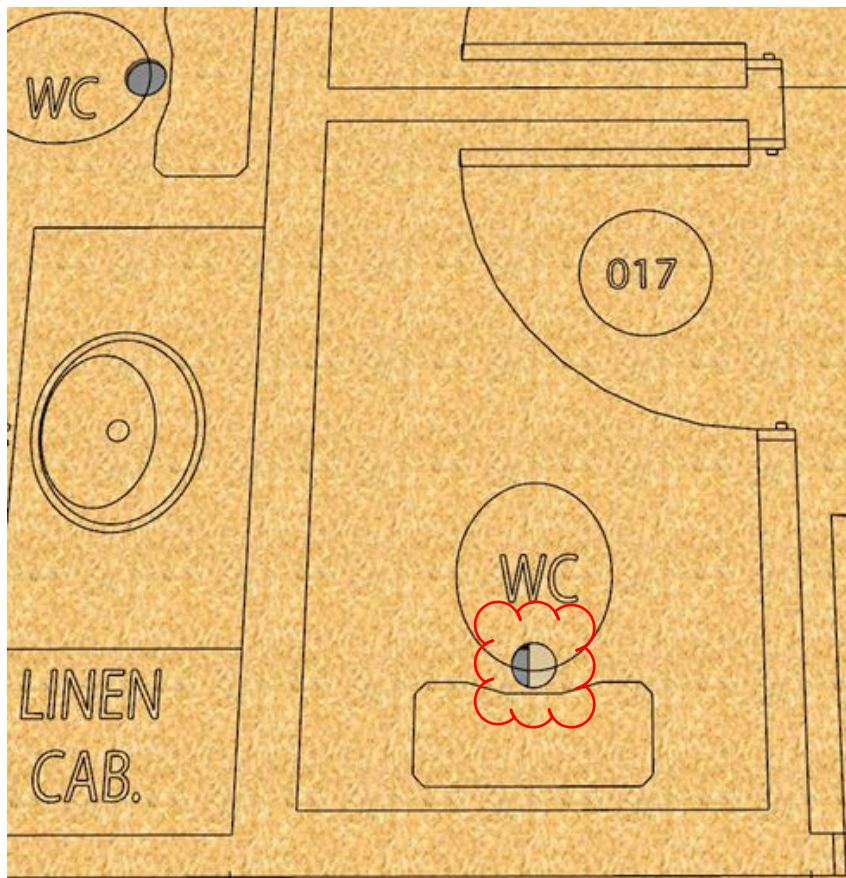
The image below shows such a clash.

Issue: A common issue that most every builder will acknowledge they have dealt with before, is when a toilet or tub/shower or other such drain winds up directly over top of a floor joist or truss. Neither of these elements may be cut or notched, without engineering and labor expense, to allow for the drain to fit.

At Constructability3D, we model the subfloor over the floor systems. We then attach the 2D floor plan directly to the subfloor. Not only do we build the walls using these lines, just as we do in real life on a chalk line, we cut out for these drains and can instantly see if there is a clash below with a floor joist or truss. It is much easier to handle this prior to construction!
