Common Issues #3: Conflicting Specs/Details

Example: Structural Drawings vs TJI Vendor Drawings

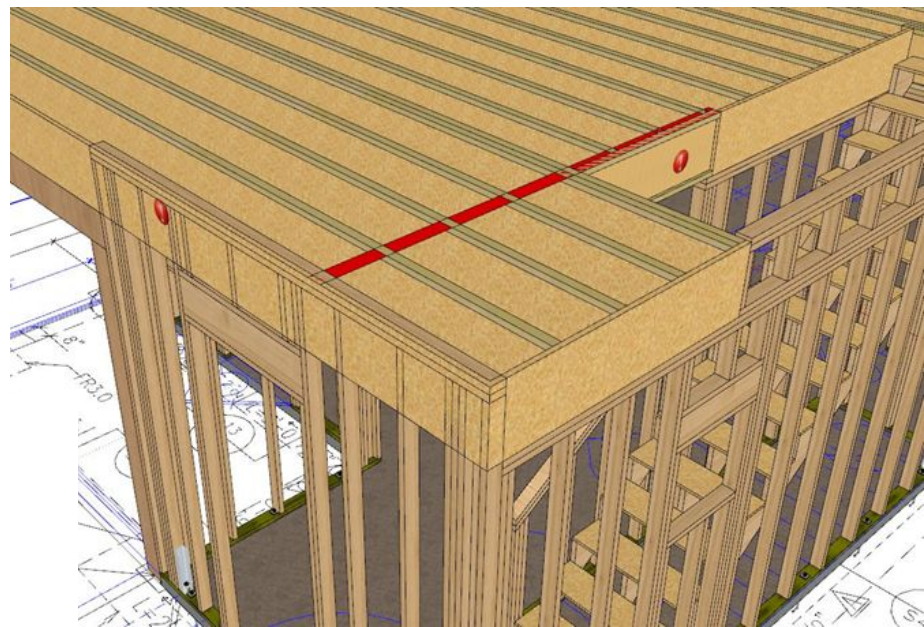
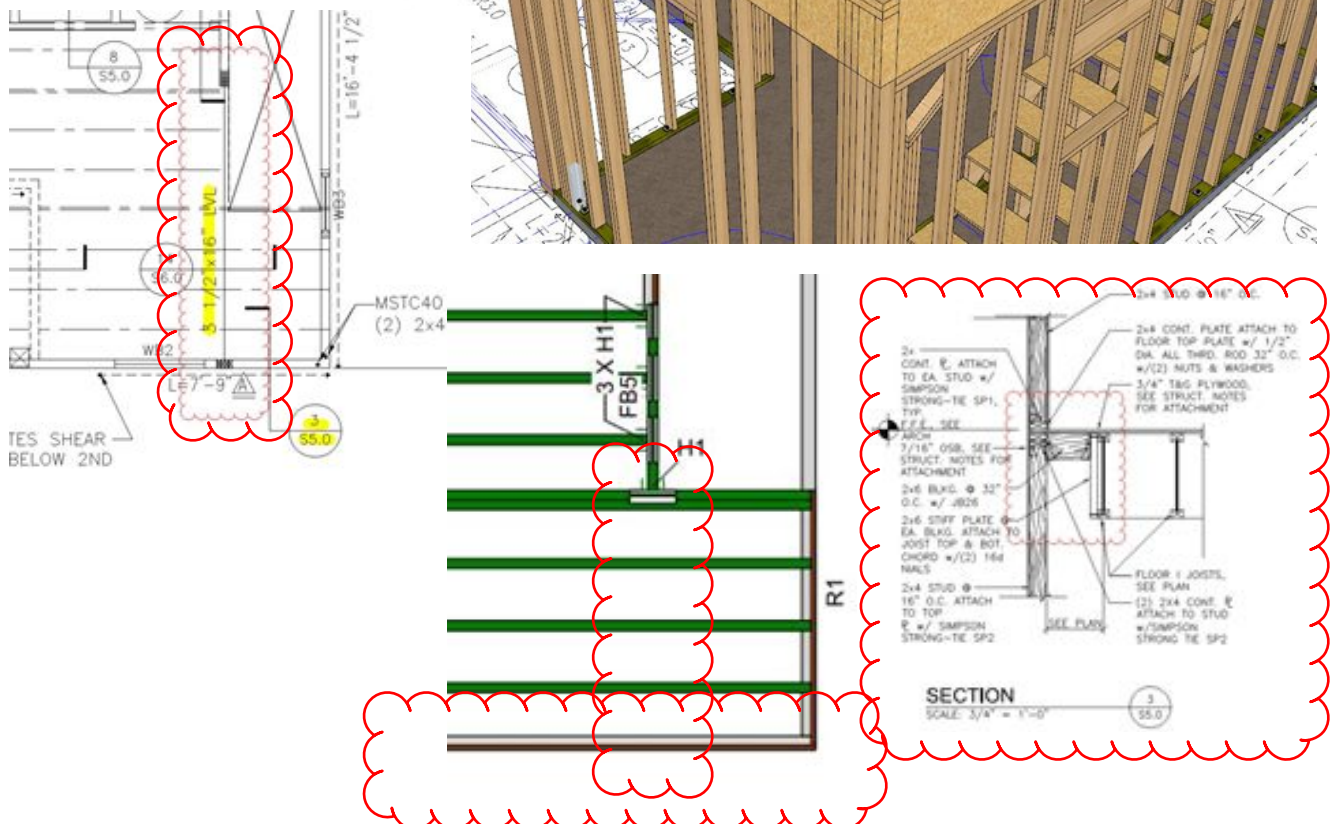
Issue: In this example, the structural engineer had specified a beam to run from stair wall to front wall. Further, the front wall was to be framed up to the underside of the subfloor of the level above - these two walls would then be bolted together. The TJI vendor generated a plan and layout (and ORDER) which did not include the beam previously specified AND they used a rim joist/band on top of standard height wall. Now, who is correct? Who will win when the county arrives for the building inspection?

- Structural plans specify 3-1/2" x 16" beam from stair wall to front wall - clearly NOT shown or included in the TJI Layout.
- The front wall is shown to be framed up to the underside of the subfloor above in the provided detail, yet the TJI layout specifies a rim joist over a standard height wall.
